「法隆寺西院伽藍と年輪年代法」

—法隆寺論争に新視点—

Dendrochronology and the Western Cloister of Hōryūji :

A New Perspective on the Hōryūji Debate

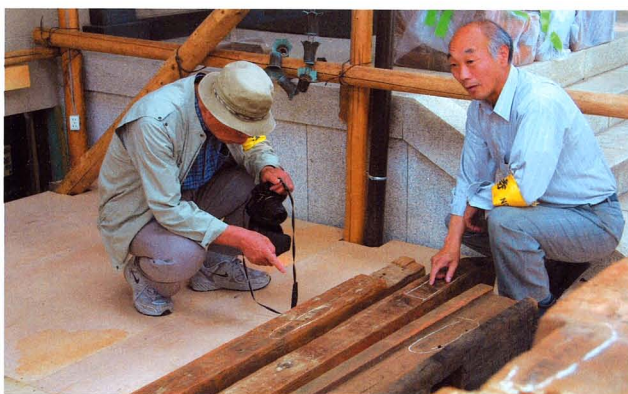
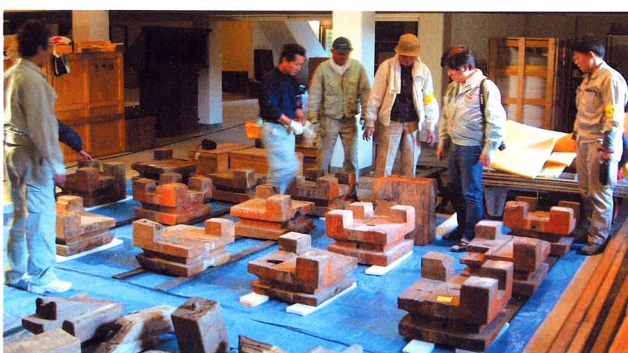
法隆寺中門部材選定風景（上・下）

今回、年輪年代法の調査対象となった木材は、金堂、五重塔、中門の昭和の大修理のときにはずされた古材や、現在建っている金堂、五重塔の内部で年代測定が可能な部材の高精細なデジタルカメラで撮影した年輪画像などを用いて107点測定した。その結果、昭和の金堂火災で焼損した天井板2点から667年、668年の伐採年が判明した。五重塔では673年頃、中門は690年代中頃に伐採された木材が使われていた。この結果を見るかぎり、金堂、五重塔、中門の順に造営されていたことが判明した。世界最古の木造建造物の建立年代に年輪年代法という科学のメスが入り、法隆寺論争に新たな謎が加わった。
